TECHNICAL & SAFETY COMMITTEE

INTERNATIONAL PARACHUTING COMMISSION (FAI)

Technical & Safety Information Notice No.	5/2013 VELOCITY SPORTS EQUIPMENT SERVICE BULLETIN SERVICE BULLETIN VSESB001, REV 0, RE MAIN RISER LOCKING LOOP WEAR. W.N. 47
Date of Issue	12 July 2013
Subject Matter and Applicability	<p>VELOCITY SPORTS EQUIPMENT SERVICE BULLETIN VSESB001, REV 0, RE MAIN RISER LOCKING LOOP WEAR.</p> <p>DATE: June 01, 2013</p> <p>SERVICE BULLETIN VSESB001, REV 0.</p> <p>SUBJECT: MAIN RISER, LOCKING LOOP WEAR</p> <p>STATUS: MANDATORY INSPECTION</p> <p>IDENTIFICATION: All main risers manufactured by Velocity Sports Equipment(VSE)</p> <p>BACKGROUND: Several main risers have been found in the field with frayed/partially cut locking loops (the white type 2A loop). The amount and location of damage on the loops varies, leading VSE to conclude there may be several contributing factors. A loop failure can result in an out of sequence main release and reserve deployment which can cause an entanglement. Due to this danger, VSE feels all main risers should be inspected according to the following Service Bulletin.</p> <p>Who can inspect: Any FAA certified senior or master parachute rigger or fore

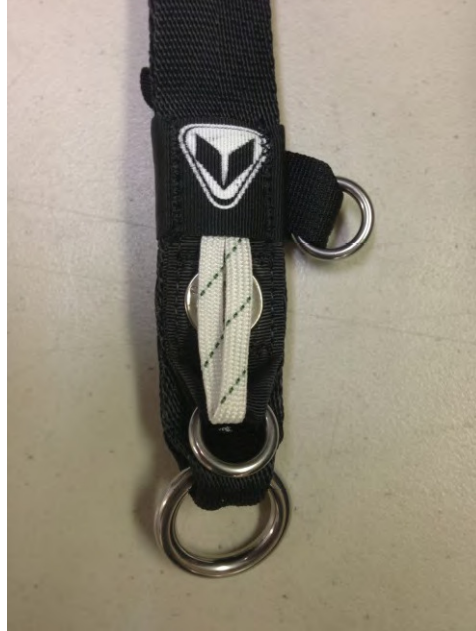
NEW LOCKING LOOP

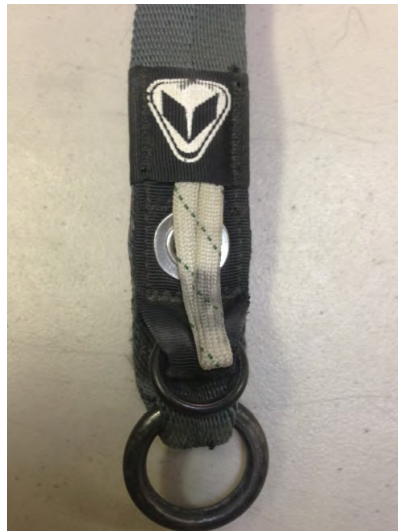
NORMAL WEAR, FRONT

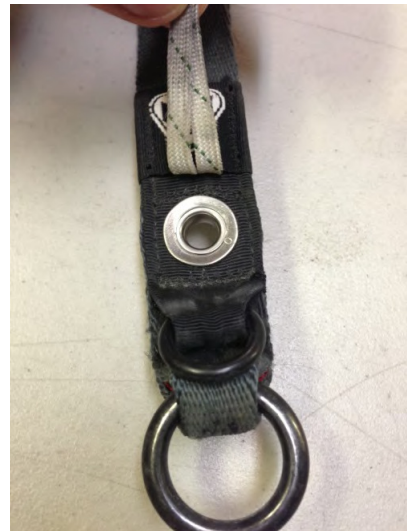
NORMAL WEAR, BACK

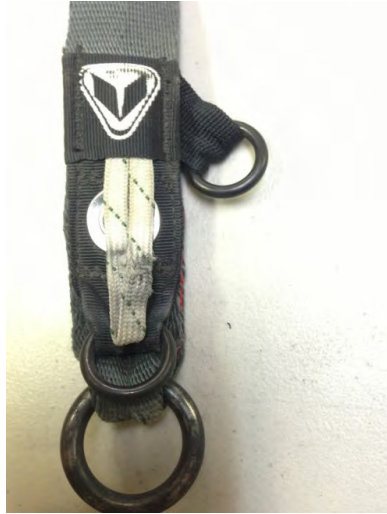
DAMAGED, FRAYED

<p>RESOLUTION:</p> <p>If the loop shows signs of damage, the rig should not be jumped and VSE should be contacted for further instructions. VSE may also ask for additional information to help determine the root cause and most effective repair. At minimum, VSE will need 2-4 photos, one of each riser loop and one of each housing grommet. Please have these available to send to VSE when you call in. In most cases, once the root cause is determined, VSE will provide a parts kit which can be installed by an FAA certified senior or master parachute rigger or foreign equivalent using the Housing Replacement Procedure provided at the end of this service bulletin. In certain cases, VSE will require the rig be returned to VSE for further inspection and repair.</p> <p>If the loop shows normal wear, the rig can continue to be jumped and no immediate repair is needed.</p> <p>VSE recommends periodic checks of the locking loops moving forward for all rigs. Minimally, these checks should be completed every three (3) months during the periodic maintenance of the 3 ring release system.</p>

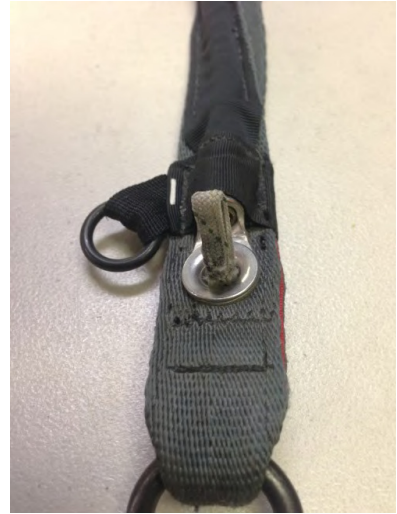
DAMAGED, FRAYED

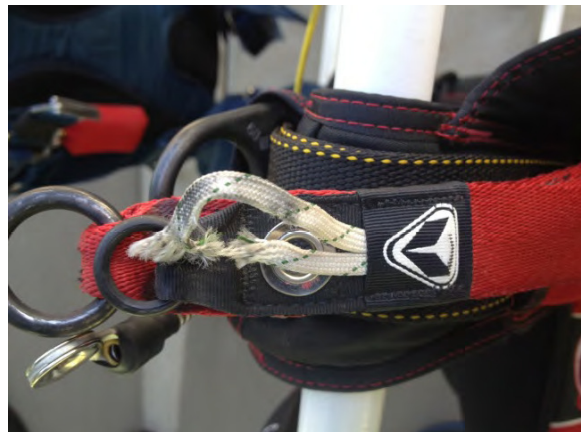
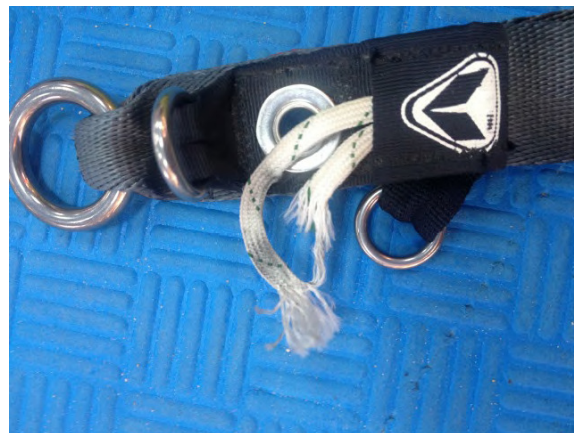
**DAMAGED,
PARTIALLY CUT**
