TECHNICAL & SAFETY COMMITTEE

INTERNATIONAL PARACHUTING COMMISSION (FAI)

Technical & Safety Information Notice No.	5/2013 VELOCITY SPORTS EQUIPMENT SERVICE BULLETIN SERVICE BULLETIN VSESB001, REV 0, RE MAIN RISER LOCKING LOOP WEAR. W.N. 47
Date of Issue	12 July 2013
Subject Matter and Applicability	<p>VELOCITY SPORTS EQUIPMENT SERVICE BULLETIN VSESB001, REV 0, RE MAIN RISER LOCKING LOOP WEAR.</p> <p>DATE: June 01, 2013</p> <p>SERVICE BULLETIN VSESB001, REV 0.</p> <p>SUBJECT: MAIN RISER, LOCKING LOOP WEAR</p> <p>STATUS: MANDATORY INSPECTION</p> <p>IDENTIFICATION: All main risers manufactured by Velocity Sports Equipment(VSE)</p> <p>BACKGROUND: Several main risers have been found in the field with frayed/partially cut locking loops (the white type 2A loop). The amount and location of damage on the loops varies, leading VSE to conclude there may be several contributing factors. A loop failure can result in an out of sequence main release and reserve deployment which can cause an entanglement. Due to this danger, VSE feels all main risers should be inspected according to the following Service Bulletin.</p> <p>Who can inspect: Any FAA certified senior or master parachute rigger or fore

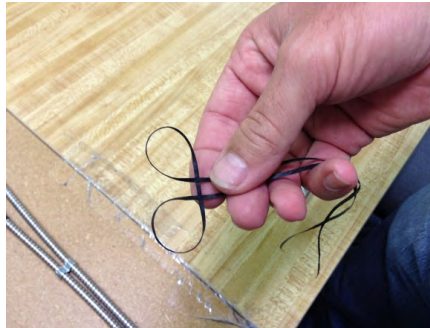
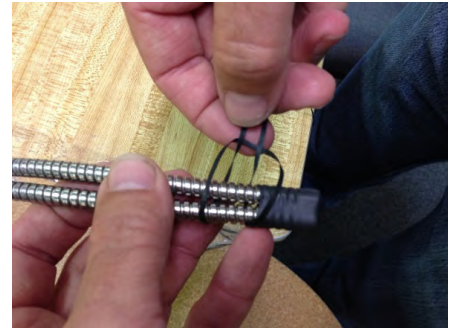
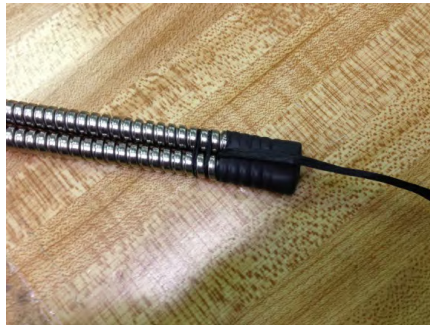
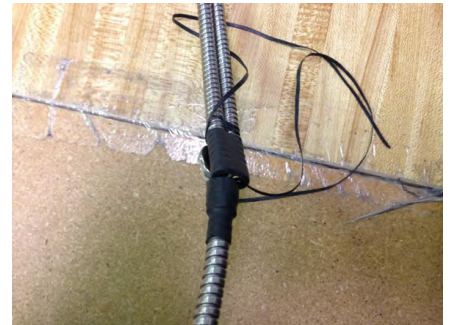
3. Attach the tack cord to both sets of housings

a. Tie tack cord on new housings using the double loops shown (end with both housings shrink wrapped)

b. Tie tack cord end of old housing (end with amp connector/grommet)

c. Ensure the tack cord is secure so it doesn't come undone inside the yoke

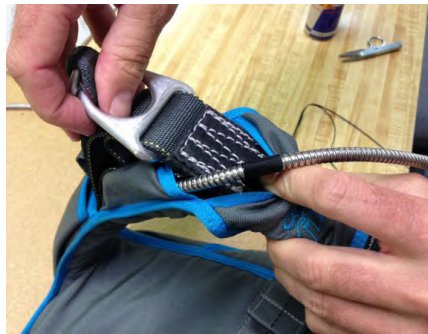
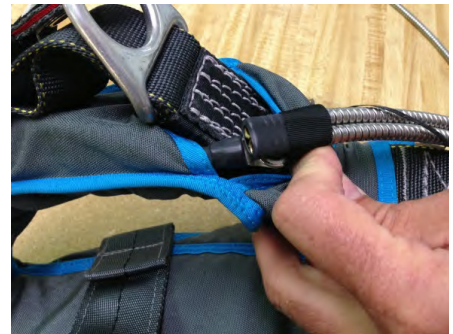
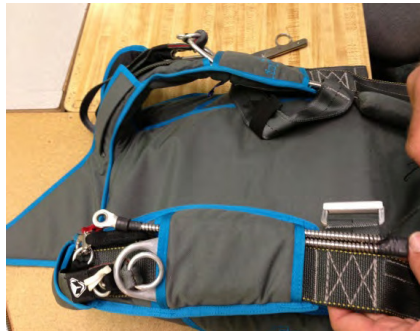
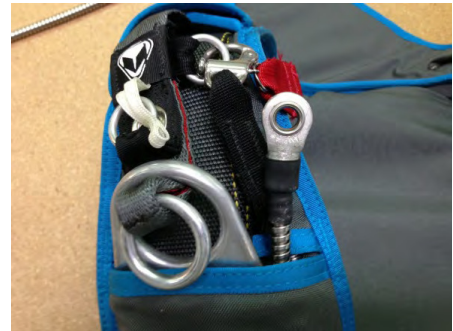
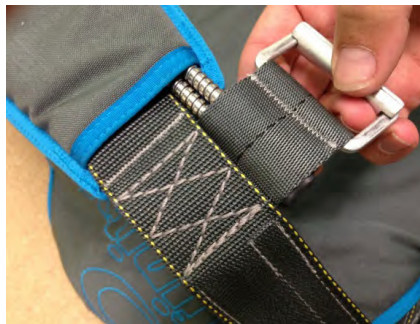
4. Pull the old housings out as you feed the new housings in.
 - a. Partially expose the MLW and $\frac{3}{4}$ " tape loop; both located within the left mudflap
 - b. Pull housing through from below the right side mudflap
 - c. Take care as you feed the tied ends through the binding tape loop
 - d. Take care as you feed the tied ends into the yoke
 - e. Once new housings are completely pulled through, position the new housings so short housing grommet is flat and facing back of rig
 - f. Remove tack cord
 - g. Feed housings through gap in chest strap

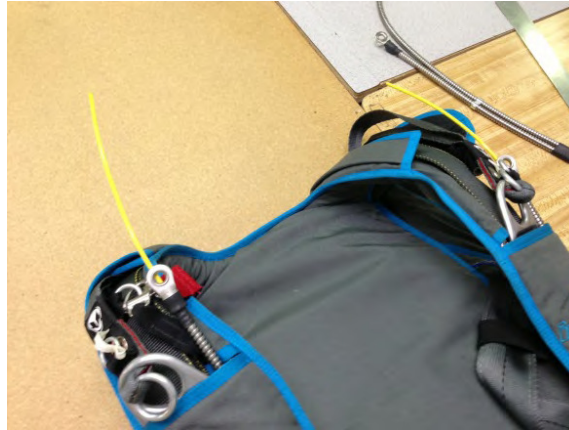
a. Check cable lengths. The cable protruding from the RSL side housing must be 1" longer than the non RSL side.

b. Cable should be 6" on non-RSL side; 7" RSL side when measuring from the end of the housing. If cables protrude less than 4/5" respectively, the handle should be replaced.
